Manhole Inspection Summary

Manhole # S23M1_002MH

Location Address: **3025 MALLVIEW DR**

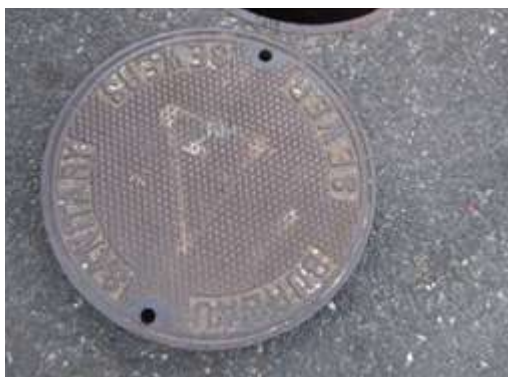
COVER PIC

Condition: **Sound**

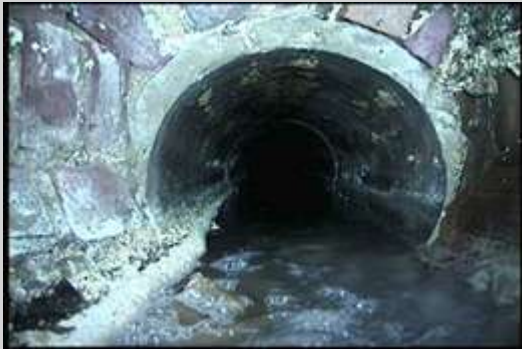
12 O'Clock Outflow

10 in. Circular Gravity Sewer
Pipe Out @ 12 O'Clock

Pipe Height: **10.8** (in.) Rod and Bar (Angled)
Pipe Material: **Clay** ☐ Pipe Lined
Invert Depth: **13.89** (ft.) Flow Characteristics: **None**
Deposits: ☒ None ☐ Mud ☐ Sludge ☐ Debris ☐ Grease
Silt Depth: **0** (in.) Deposits Extent:
Infiltration: **None** Pipe Seal Cond: **Sound**

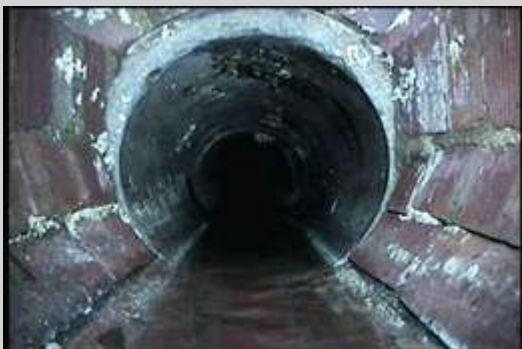
6 O'Clock Inflow

10 in. Circular Gravity Sewer
Pipe In @ 6 O'Clock

Pipe Height: **10.8** (in.) Rod and Bar (Angled)
Pipe Material: **Clay** ☐ Pipe Lined
Invert Depth: **13.75** (ft.) Flow Characteristics: **None**
Deposits: ☒ None ☐ Mud ☐ Sludge ☐ Debris ☐ Grease
Silt Depth: **0** (in.) Deposits Extent:
Infiltration: **None** Pipe Seal Cond: **Sound**

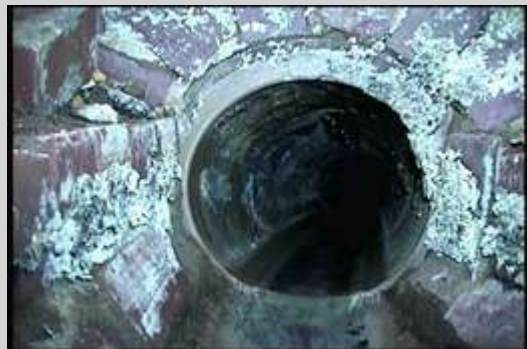
9 O'Clock Inflow

10 in. Circular Gravity Sewer
Pipe In @ 9 O'Clock

Infiltration: **None** Pipe Seal Cond: **Sound**
